REMOVAL OF SCALE FROM THE TOTAL DUNBAR 16" MULTI-PHASE PIPELINE

Jon Hawes
TOTAL E&P UK PLC
Crawpeel Road, Altens Industrial Estate
Aberdeen AB12 3FG UK
T: +44 1224 297 000
F: +44 1224 296 959
jon.hawes@total.com

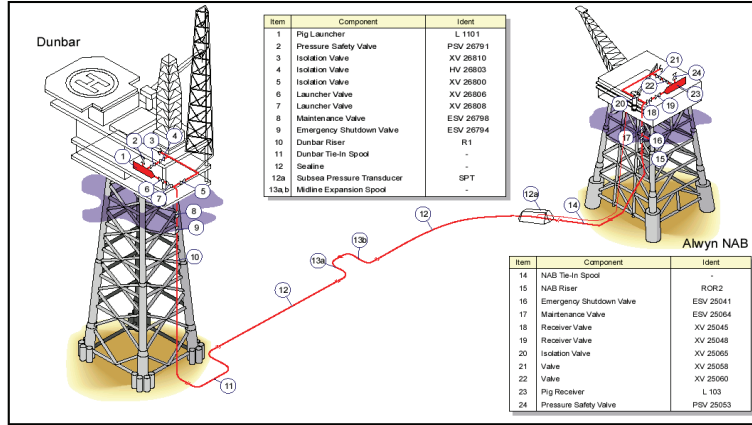
Figure 1 – Dunbar to Alwyn Export Pipeline

The Alwyn and Dunbar Fields are located to the east of the Shetland Islands, and are operated by TOTAL E&P UK PLC. **Figure 1** shows the Dunbar export pipeline running from the Dunbar Platform to the North Alwyn Bravo Platform, a distance of some 22km in 110-140 metres of water.

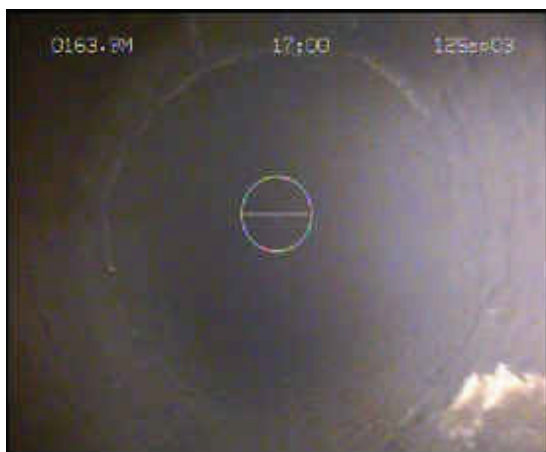
Figure 2 – Scale near bottom of Riser (2003)

- During the dewatering of the pipeline, Tracerco injected a radioactive isotope at Dunbar and time of flight to Alwyn was measured. With the known flowrates, an estimate of the remaining pipeline volume was arrived at. When compared to theoretical volume, an estimate of scale volume could be determined.
- Inspectahire carried out a repeat video survey, this time to the bottom riser bend. This showed that the scale was continuous to the bottom bend [Figure 2], but that the worst area of deposition was at the top bend [Figure 3].
- In addition, Inspectahire deployed a sonar head to measure the minimum bore of the riser. This gave a worst case measurement of approximately 10". This was backed up by the physical size of the camera assembly, which was 9" across.

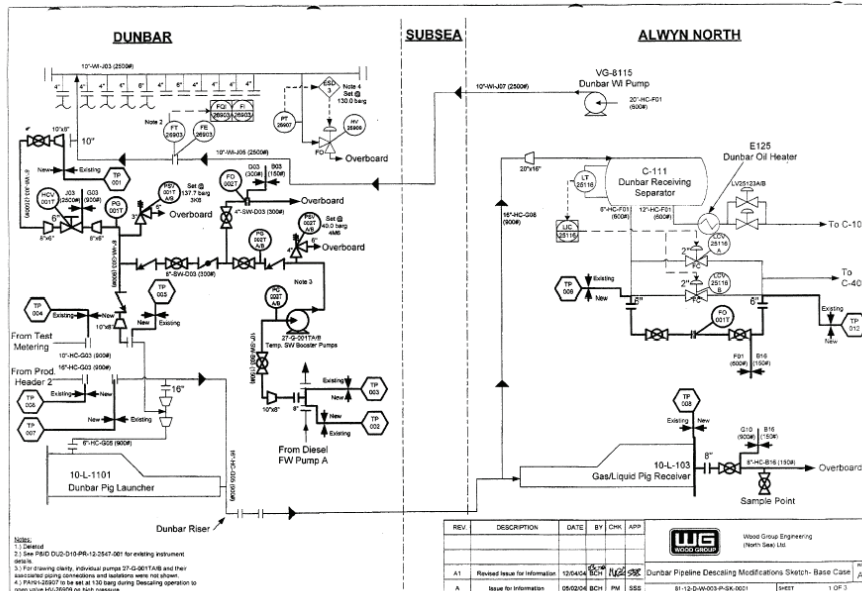
Figure 6 – Topsides Modifications

Water Injection is provided to Dunbar platform from the North Alwyn platform via a 10" pipeline. With a difference in pressure rating between the two pipelines, 366 barg for the WI line, and 137 barg for the Dunbar pipeline, a pressure protection system had to be incorporated into the design. The water feed was taken from the Water Injection Header downstream of the existing isolation valve on Dunbar. Beyond this, the temporary pipework was teed in, with a second isolation valve, a flow control valve (hand operated with a small bypass), before the two high pressure PRV's. The pipework was then routed through an NRV before the contingency supply line tee, and then to the Pig Launcher. This is shown on the left hand half of **Figure 6**.

The Contingency Water Supply is provided from one of the Fire Pumps. The Fire System has a very low pressure rating, and so a pressure protection system also had to be incorporated into this design. Temporary booster pumps and hose were hired in, and these were installed on the drill deck, the only place where there was sufficient lay down area. The water supply from the Fire Pumps was routed through a filter to the booster pumps, before passing the two low pressure PRV's before joining the supply line to the Pig Launcher. This is also shown on the left hand half of **Figure 6**.

For the scale and water reception facilities on topsides Alwyn, a modified replacement Pig Receiver Door was fabricated, with a 6" outlet. Incorporated on the end of this nozzle was a 6" valve, and a sampling point. Downstream of this point, the pipework was routed via a flexible hose to sea level, to facilitate discharge. This is shown on the right hand half of **Figure 6**.

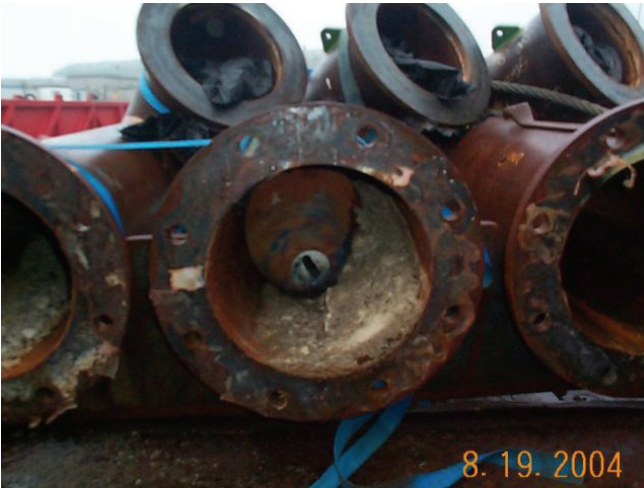
Figure 8 – Tool 5 (PT-RRT-RST) in Receiver Cassette

Figure 8 shows the fifth Riser Cleaning tool in the cassette receiver onshore along with scale debris. **Figure 9** shows the mound of scale debris from the riser cleaning process, estimated at 6m by 3m by 1m high.

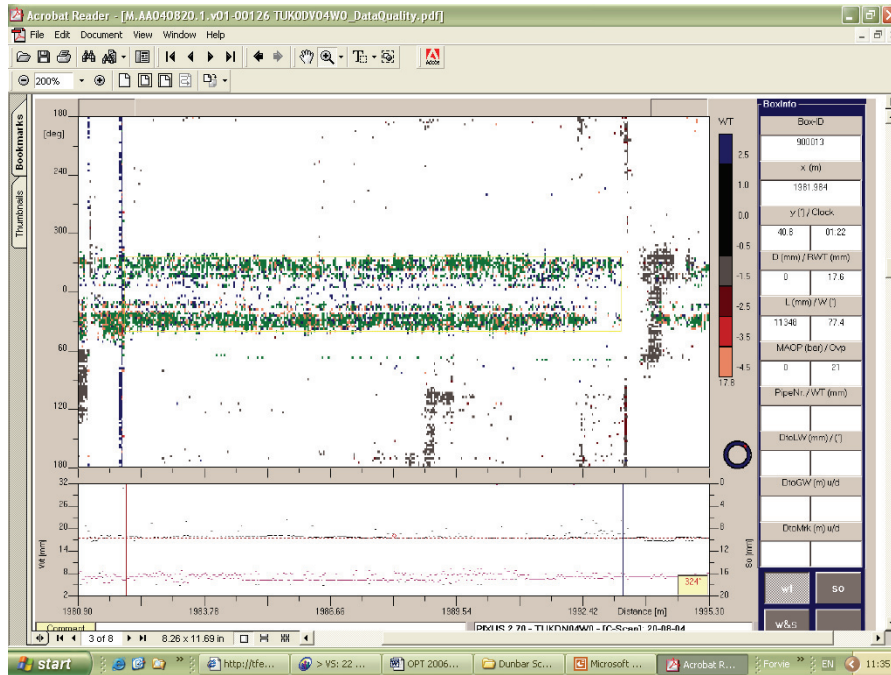
Figure 10 – Residual Scaling on Wall of Pipeline

The final stage of the operation was to run the Intelligent Pig, The run time of this was 5:12 hrs, representing a pig speed of 1.2m/s. A qualitative analysis of the data shows that 3.5% of data was lost due to UT probe problems, and 2.4% due to residual scaling. The residual scale was located in two narrow bands located either side of the 12 o'clock position (see

Figure 10), and was initially 2mm thick (at KP 1.9), reducing the further away from Dunbar. By KP 8.5, the residual scale, while still evident, did not affect the Intelligent Pig data.

Subsequent to the cleaning operation, TOTAL E&P UK PLC, in conjunction with Reinhart in Switzerland, now run cleaning tools in the pipeline on a regular basis, while still in production. This maintains the pipeline clean enough to carry out further Intelligent Pig Inspections if and when required.
